## AVIATION INVESTIGATION REPORT

A03C0068

### FLIGHT CONTROL MALFUNCTION

GOVERNMENT OF CANADA  
DEPARTMENT OF TRANSPORT  
BEECH KING AIR C90A C-FGXU  
DAUPHIN, MANITOBA 25 NM SW  
13 MARCH 2003

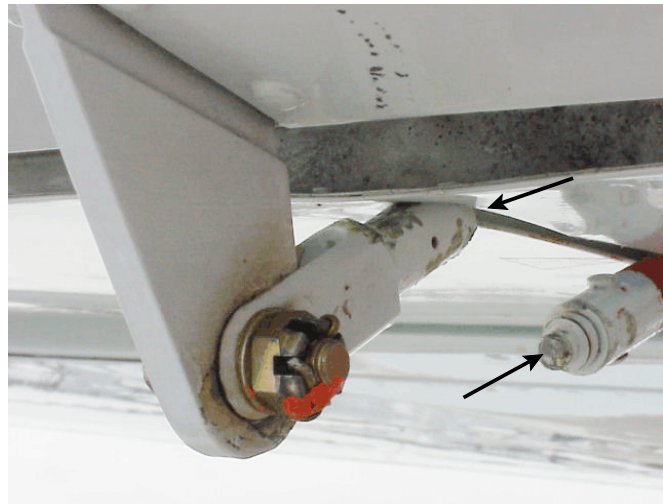
The occurrence happened approximately 150 flight hours after the inspection, at an airframe time of 8050 hours. An examination of the aircraft after the occurrence revealed that the left elevator trim-tab pushrod had failed at the threaded rod, flush with the surface of the jam nut, adjacent to the adjustable fork-end (see Photo 1). The fork-end was seized at a right angle to the trim-tab horn. The pushrod cutout in the elevator lower surface showed rub marks from the jamming of the fork-end in several locations in the cutout after the failure occurred. The torque on the attachment hardware was checked and found to be 90 inch-pounds. The manufacturer's recommended torque is 25 to 30 inch-pounds, with a provision to go as high as 50 inch-pounds to aid in aligning the slot in the castellated nut. It was reported that a torque wrench had been used during the installation of the castellated nut.

**Photo 1.** Failed left elevator trim-tab pushrod

The trim tab and attachment hardware was forwarded to the Transportation Safety Board of Canada (TSB) Engineering Branch for examination. Scanning electron microscope examination of the fracture face on the threaded rod showed fatigue originating in a thread root. The fatigue

cracking had progressed to overstress rupture with no noticeable final overstress region, suggesting that the failure occurred under normal service loads when the crack reached critical size. Metallurgical testing of the pushrod showed that it met material specifications.

The elevator trim pushrod failed as the result of fatigue cracking of the threaded section of the rod end. The fatigue crack was initiated by the increased bending load generated from a progressively stiffening pushrod to trim-tab attachment. The original fit between the inner and outer bushings was less than ideal, with an interference fit occurring between these two parts at points around the interface. The non-cylindrical nature of the outer bushing inner bore is consistent with the non-cylindrical nature of a new bushing found in TC stores. However, it could also be indicative of manual reaming, some time after manufacture, to facilitate the insertion of the inner bushing. Reaming of the bushings without the associated drawings could lead to a risk of seizure if the dimensional and out-of-round limits are not strictly observed. TC, Aircraft Services indicates that the associated drawings for this practice are not readily available to aircraft maintenance engineers. Movement between the two ill-fitting bushings, aided by the higher-than-prescribed installation torque on the through bolt, likely produced the galling, which resulted in eventual seizure.

On 21 March 2003, TC issued a Service Difficulty Alert, AL-2003-03, recommending that operators of Raytheon/Beech 90 series aircraft disassemble and thoroughly inspect the elevator trim-tab hardware installation and ensure that the inner bushing rotates freely.

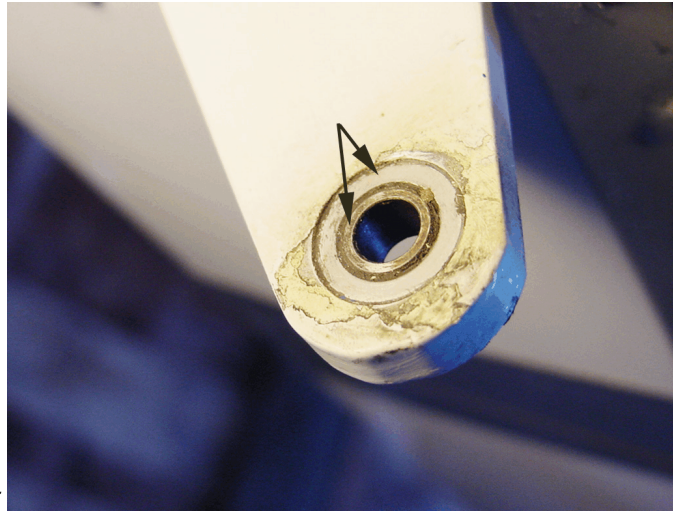
**Photo 2.** Inner and outer bushing arrangement

Again, a force gauge was used to measure the force required to rotate the clevis; the results averaged 52.7 pounds of force. It was noted during the tests that the inner bushing remained fixed in the outer bushing and the clevis rotated about the inner bushing (see Photo 2). The clevis is designed to remain fixed to and rotate with the inner bushing.

The inner bushing was removed and a significant amount of non-uniform, circumferential galling<sup>2</sup> was observed extending around the entire circumference of the outer surface of the inner bushing. A dimensional check against the manufacturer's specifications showed that the inner bore of the outer bushing was undersized and non-cylindrical, while the diameter of the inner bushing was oversized, resulting in an interference-fit<sup>3</sup> between the two bushings and the non-uniform galling. The manufacturer's designed clearance range is between 0.0001 and 0.0016 inches; the measured clearance was between 0.0000 and -0.0013 inches.

Because the bushing had seized, the trim pushrod had rotated about the inner face of the clevis and outer faces of the inner bushing. However, the through bolt was overtightened, which effectively eliminated rotation and increased the bending loads on the pushrod until it eventually failed in fatigue. This whole process was considered to have been progressive in nature: as assembly lubricant was displaced, fretting debris accumulated, galling/wear developed, and friction in the overall assembly increased. The steel-on-steel design of the elevator trim-tab bushings increases the risk of seizure if there is inadequate lubrication.
